# Field Trials of Aerospace Fasteners in Mechanical and Structural Applications

## Abstract

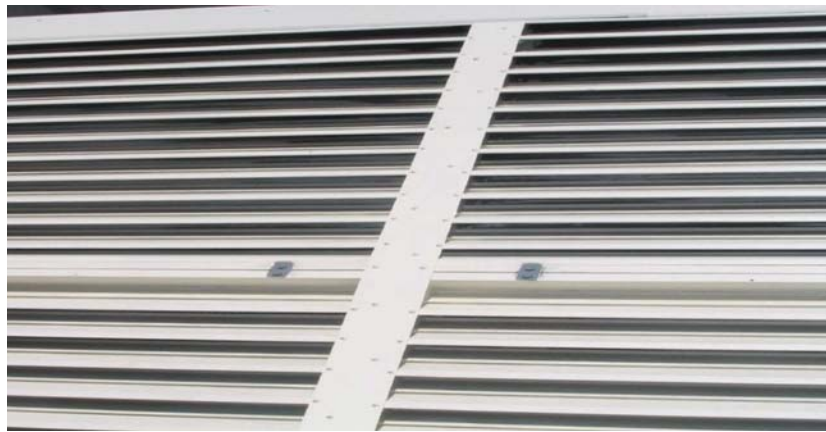
**Fig. 5** Photo taken in June 2005, showing original Al 6061 flat strip riveted louver structure and two mullion sections connected and secured on Level 28 (identical to Level 29)

(Level 29) and façade (Levels 26–28) was completed in June 2005. The building has been inspected regularly in order to confirm that the rectification remained both intact and corrosion-free. The last inspection was carried out on March 29, 2017. At that time, several of the Al 7075/Al 5056 rivets were extracted from various locations around the building. Replacement rivets were identical to those used in the original rectification. Visual inspection revealed no obvious damage or apparent corrosion to either the rivets or aluminum structures. As suggested in Fig. 4, the rivets appeared to be in pristine condition. These images may be contrasted with the appearance of the structure following rectification in June 2005, shown in Figs. 5–7.

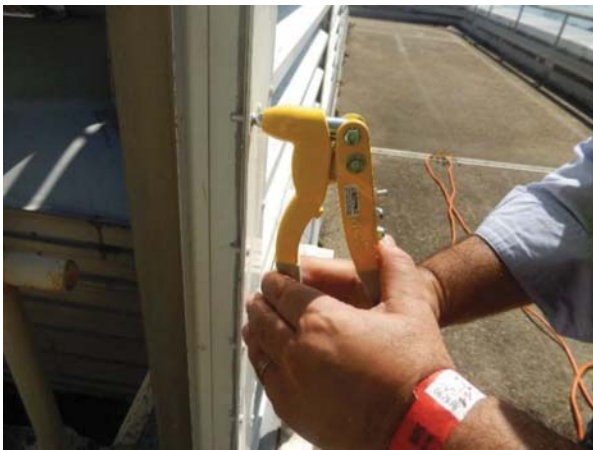
**Fig. 10** Installation of new replacement rivets where 12-year-old rivets were extracted in March 2017

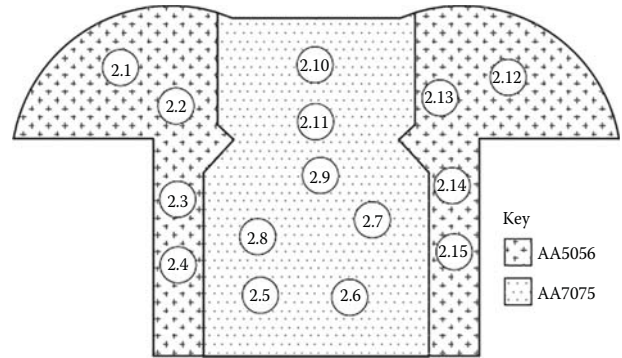
**Fig. 12** Sample 2—Longitudinal cross section of 12-year-old rivet, showing mandrel on inside, sleeve on outside, and locations for microhardness testing

Figures 11–13 show a schematic of the cross sections of the samples that were sectioned and prepared using a diamond blade for analysis. The nomenclature uses the formalism in which the first number refers to the sample (1, 2, or 3) and the second number identifies the location of the analysis.

**Table 2** Locations (Figs. 11–13), Vickers Microhardnesses (VHN), and alloy types

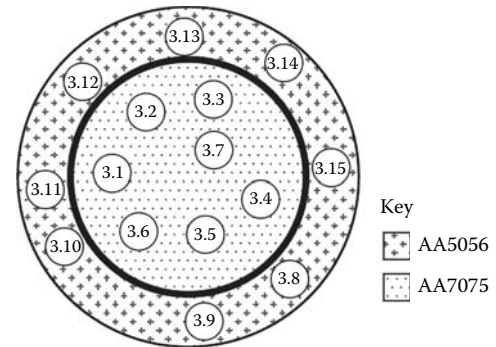
**Fig. 13** Sample 3—Diametral cross section of new rivet, showing mandrel on inside, sleeve on outside, and locations for microhardness testing
